Fannie Mae Value Acceptance

5220 NASH DR
THE COLONY, TX 75056

FNMA UPD

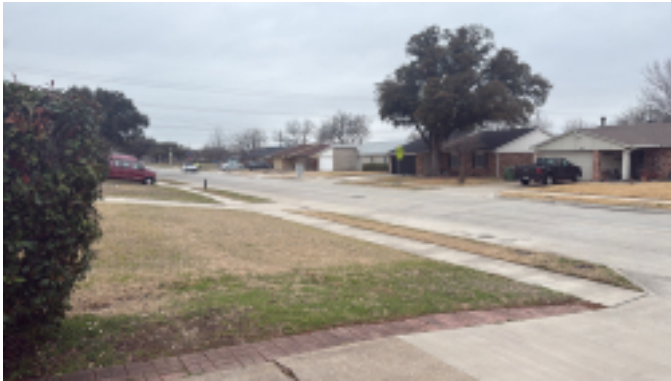
Name	Sub Type	View Quality	Description
Site Feature View	OVERHEAD_ELECTRIC_POWER_TRANSMISSION_LINE	PARTIAL	Power lines to the right of the property
Non Residential Use	NONE_OBSERVED	--	--
Adverse Condition	NONE_OBSERVED	--	--
Site Feature Location	RESIDENTIAL	--	Residential SFR neighborhood
Property Improvement	DECK	--	Outdoor deck

OVERHEAD_ELECTRIC_POWER_TRANSMISSION_LINE

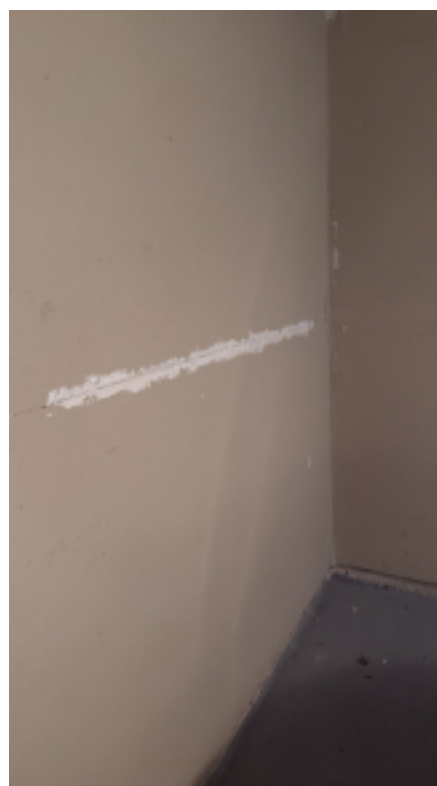
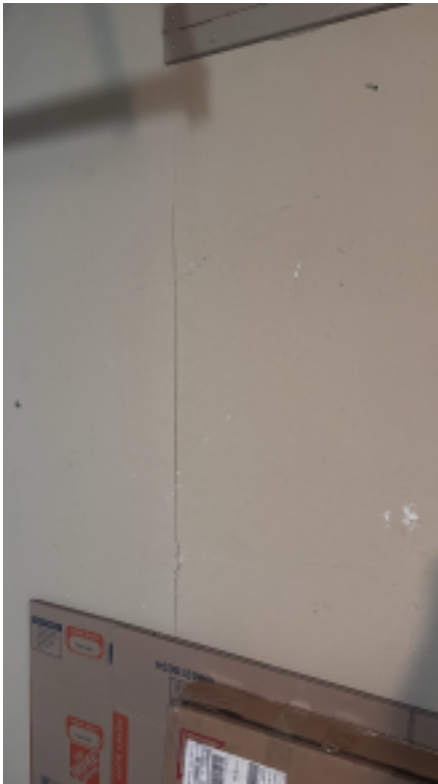
Component	Deficiency Type	Detail Name	Severity	Description
INTERIOR_WALLS	MISSING	OTHER	No	Dry wall separation

INTERIOR_WALLS

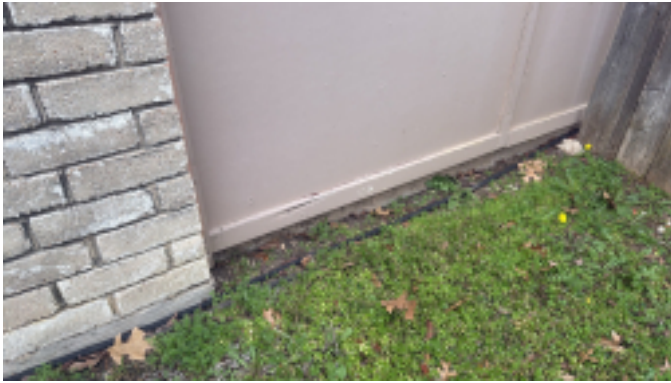
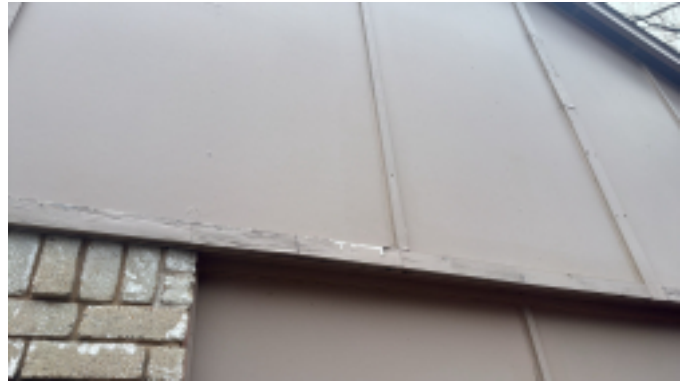
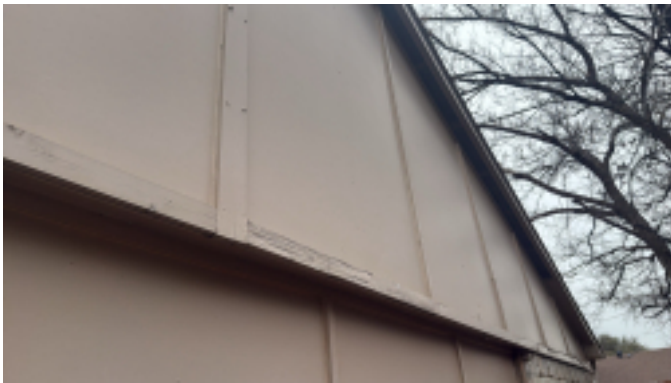
Component	Deficiency Type	Detail Name	Severity	Description
DRIVEWAY	DAMAGE	--	No	cracks on driveway
SIDING	OTHER	--	No	Siding wood rot

SIDING
