Fannie Mae Value Acceptance

5220 NASH DR
THE COLONY, TX 75056

FNMA UPD

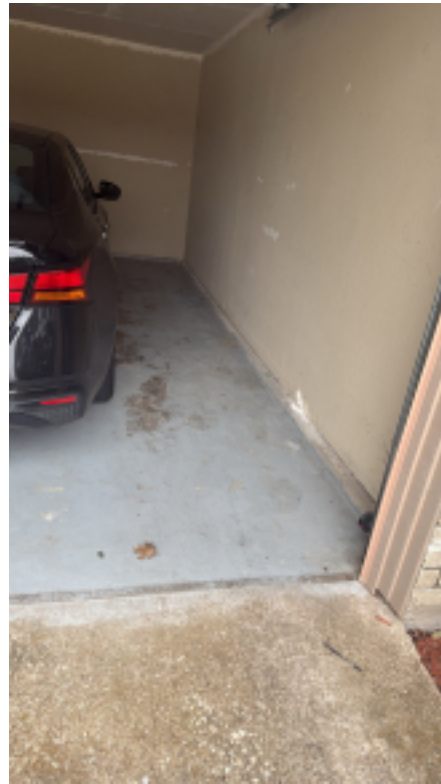
INTERIOR GARAGE

Component	Deficiency Type	Detail Name	Severity	Description
INTERIOR_WALLS	MISSING	OTHER	No	Dry wall separation
